# National Register of Historic Places Inventory—Nomination Form

historic Kirk, Elisha, House (PREFERRED)

and or common Emery House

Elisha Kirk House, Cecil County  
Continuation sheet Maryland Item number 7

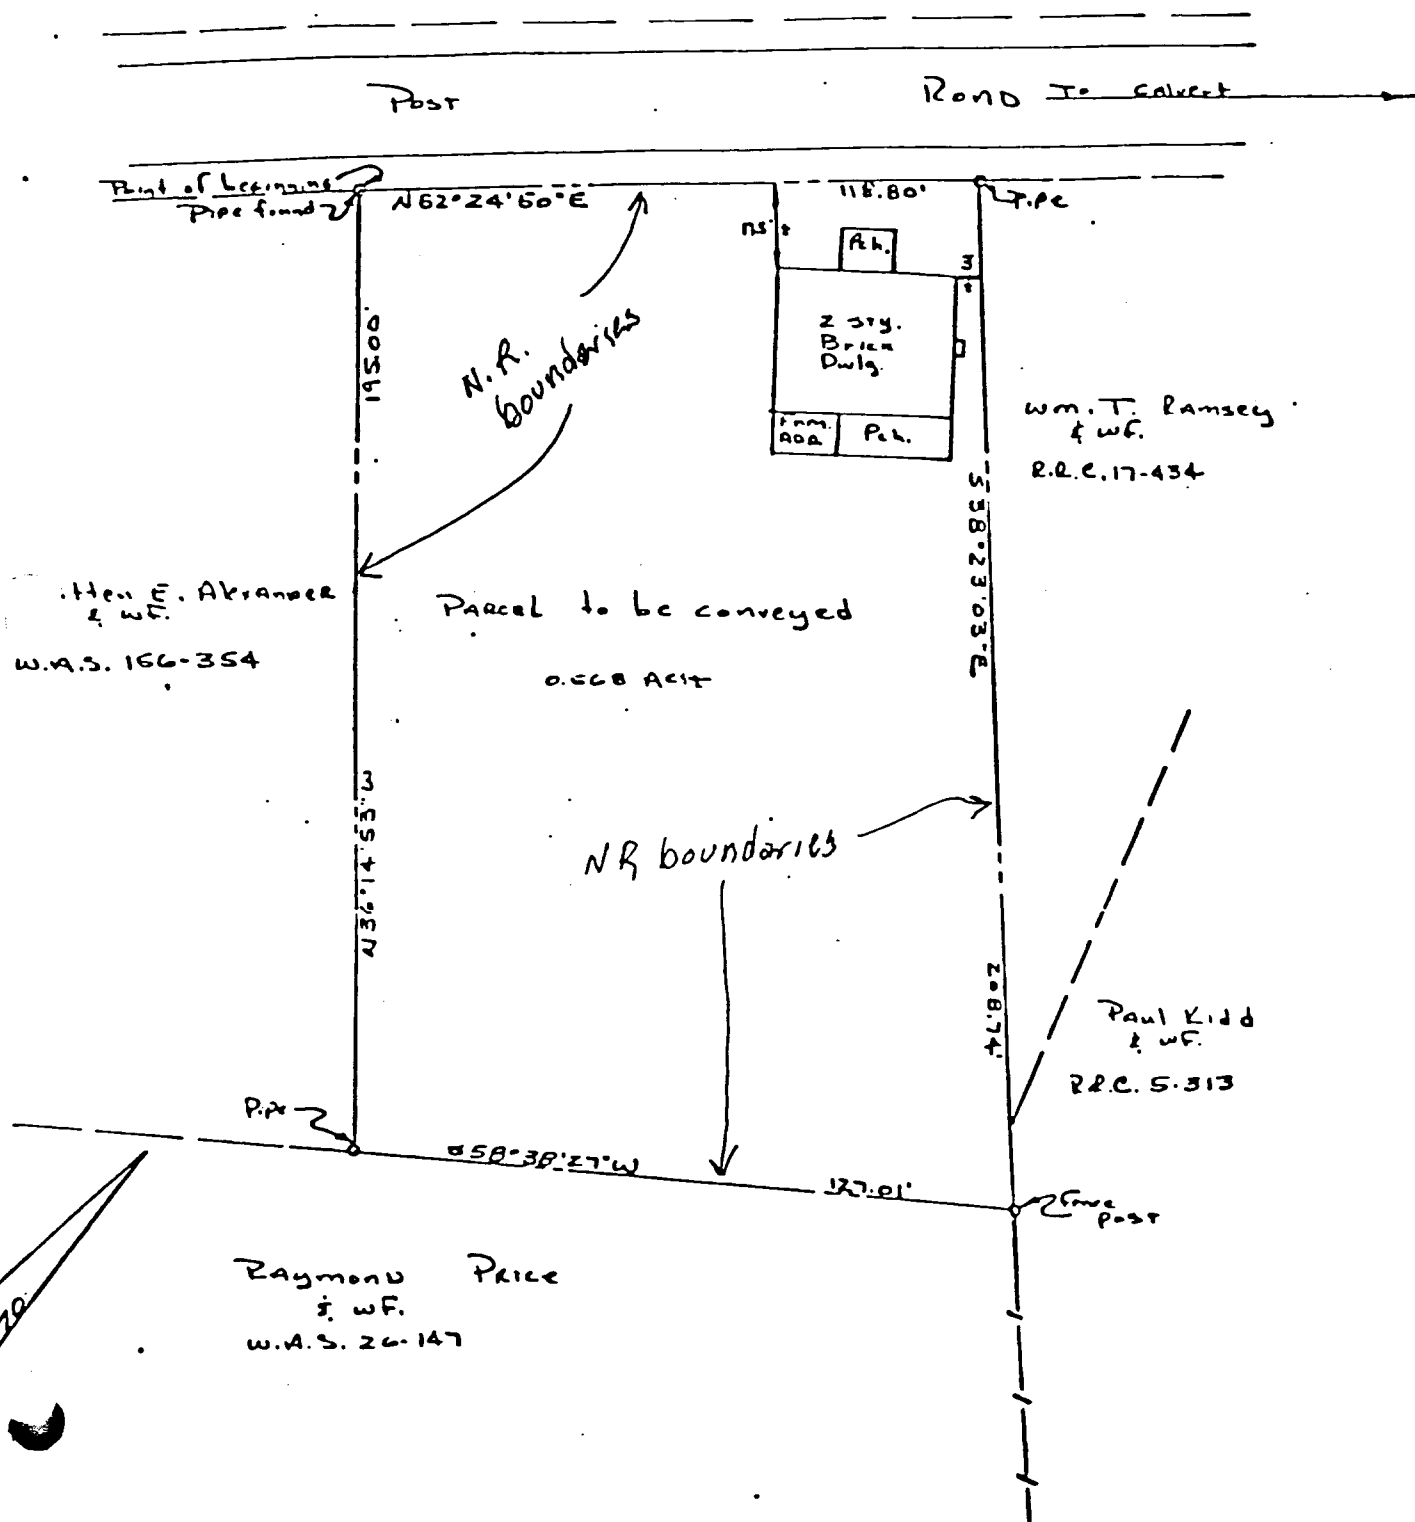
National Register boundaries

The boundaries of the property being nominated are delineated on the enclosed map labeled National Register Boundaries.
